Name of Dam: Johns Creek No. 4

Location: Craig County, State of Virginia

Inventory Number: VA 04504

PHASE I INSPECTION REPORT

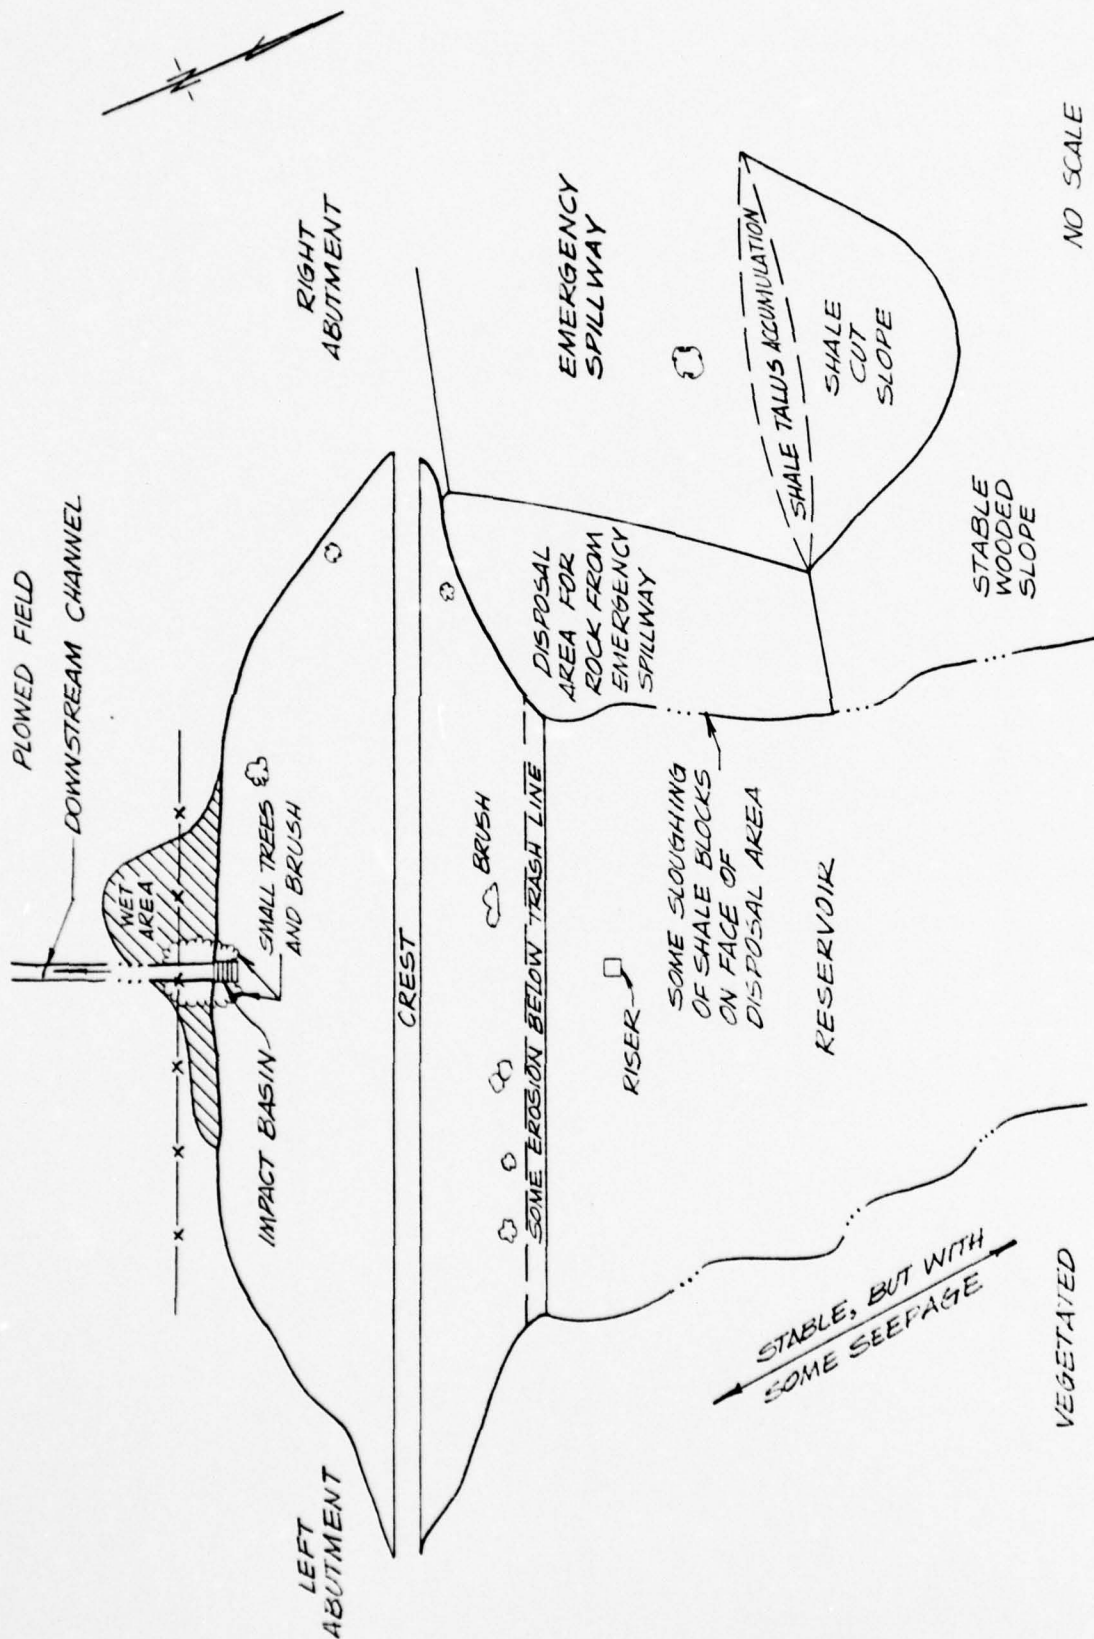
PLATE 1

FIELD SKETCH

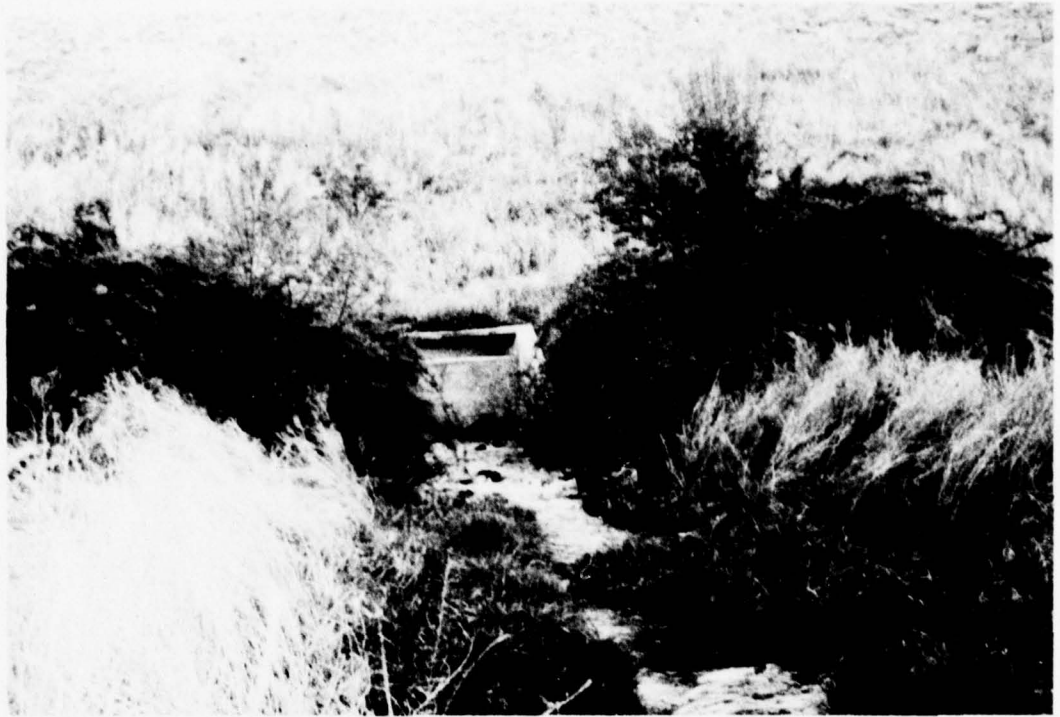
PHOTO 3. Impact Basin and Outlet Channel

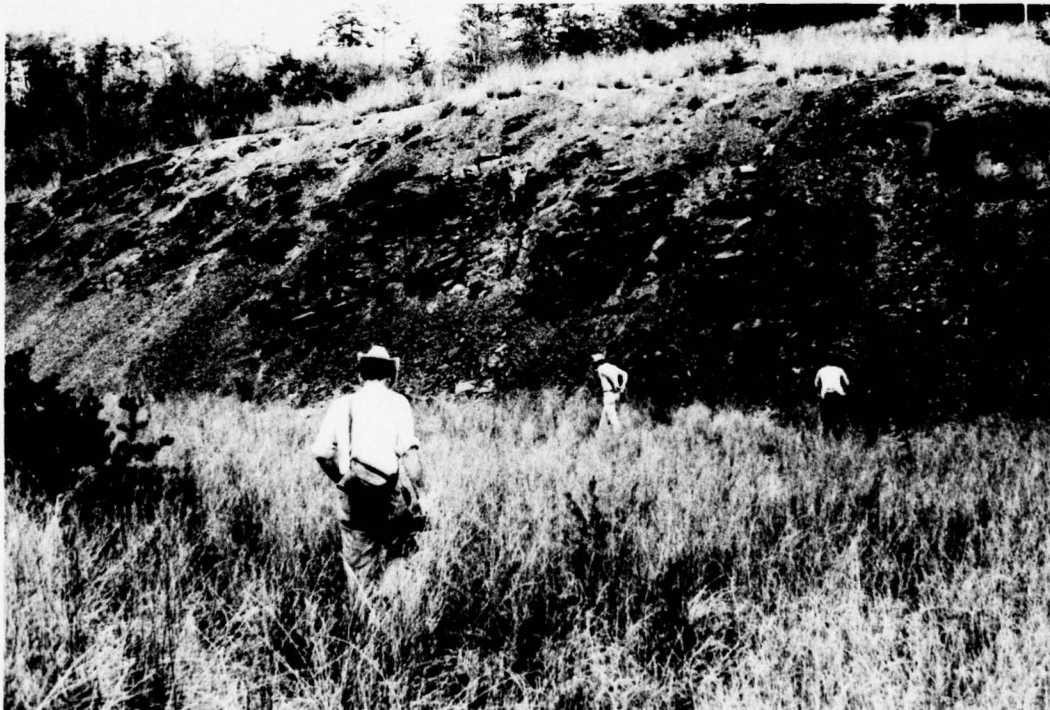
PHOTO 6. Right Cut Slope of Emergency Spillway

VISUAL EXAMINATION OF	OBSERVATIONS	REMARKS OR RECOMMENDATIONS
CONTROL SECTION	The control section is 250 ft. wide and 30 ft. long with a crest elevation of 1892.9 ft. M.S.L. and is heavily vegetated. The right cut slope of the emergency spillway is sloughed due to the weathering of exposed shale on the cut face.	
APPROACH CHANNEL	The approach channel is well vegetated with a 2% adverse slope. The rock disposal area contains some sloughing and minor erosion on the reservoir slope.	
DISCHARGE CHANNEL	The discharge channel is heavily vegetated; it has a slope of approximately 3% and discharges outside of the right abutment.	
BRIDGE AND PIERS	Not Applicable

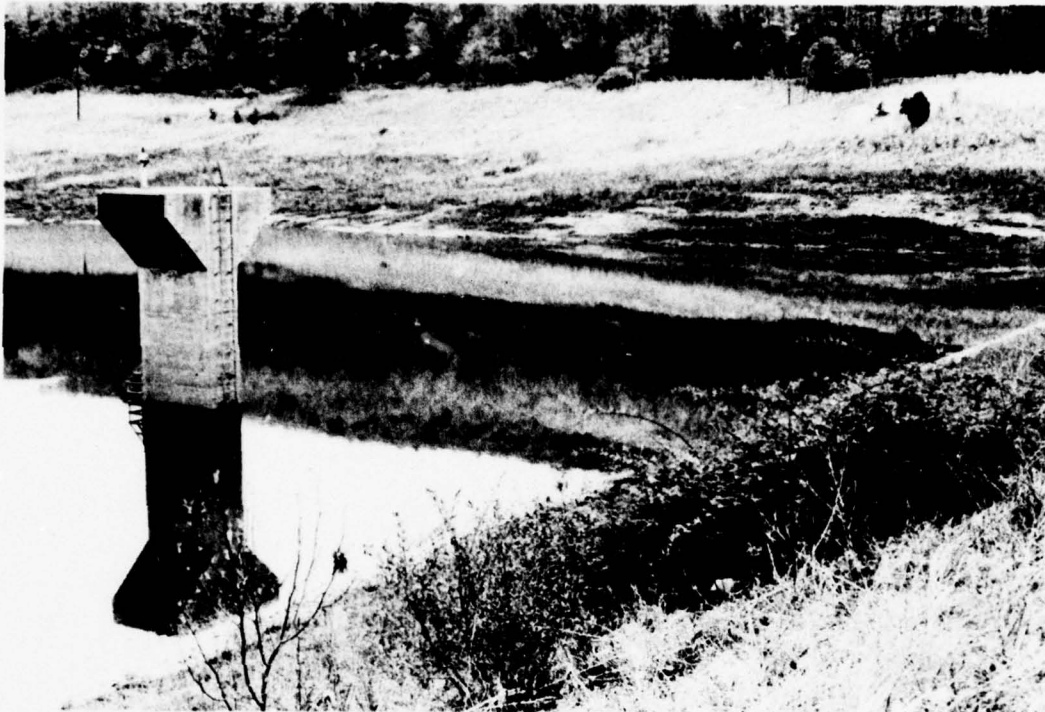
- 3.1.3 Appurtenant Structures: No apparent structural deficiencies were found during the inspection.
- 3.1.4 Reservoir Area: No apparent unstable areas were noted in the reservoir area. The area upstream from the disposal area is moderately sloped and heavily wooded. The slope on the left is relatively flat and appears to be stable although there are some wet areas (see Photo 7).

PHOTO 7. View of Left Reservoir Area from Upstream Embankment

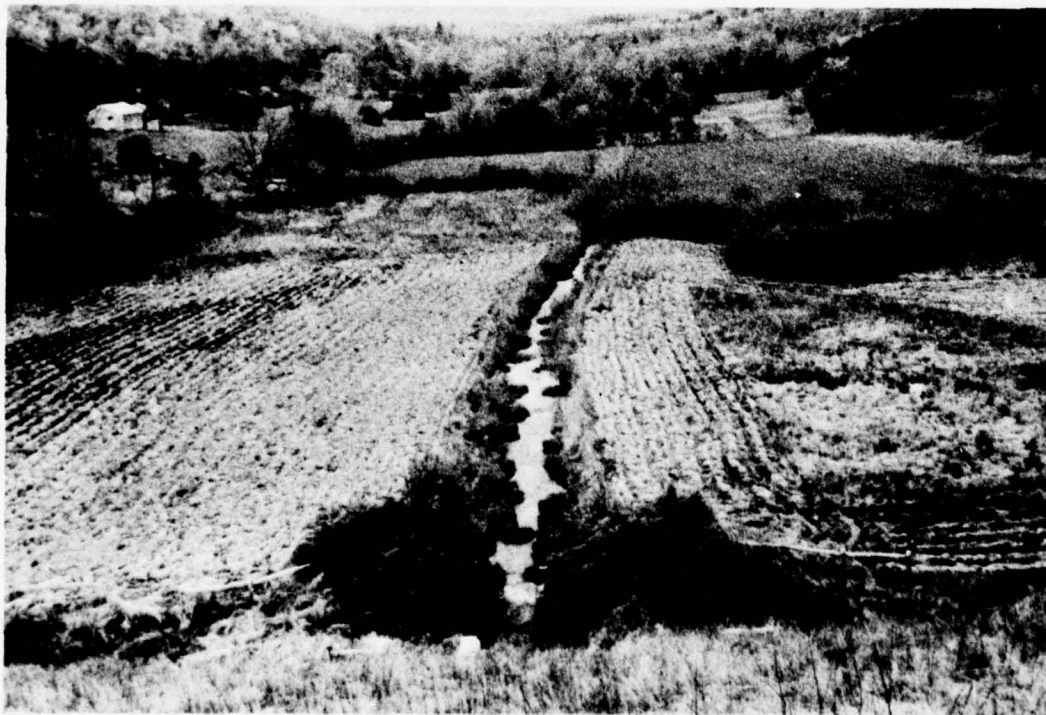
- 3.1.5 Downstream Channel: The area around the outlet structure and the upper portion of the downstream channel contains a dense growth of small trees, generally less than 2 inches in diameter, and brush which should be removed (see Photo 3). Otherwise, the downstream channel is unobstructed and the outlet works are in good condition.

PHOTO 8. View of Downstream Channel Area

- 7.2 Recommended Remedial Measures: The following repair items should be completed as part of the general maintenance of the dam:
- 1) Remove brush and small trees from the area around the outlet works and scattered locations on the embankments.
 - 2) Seed the wave erosion area on the upstream embankment with a water tolerant vegetation.
 - 3) Remove the debris from the upstream embankment slope.
 - 4) Install a staff gage to monitor reservoir levels above normal pool.
